# Navajo Abandoned Uranium Mine

## Site Screen Report

**Mine Name: Tommy**  
**Mine ID: 533**

**August 2011**

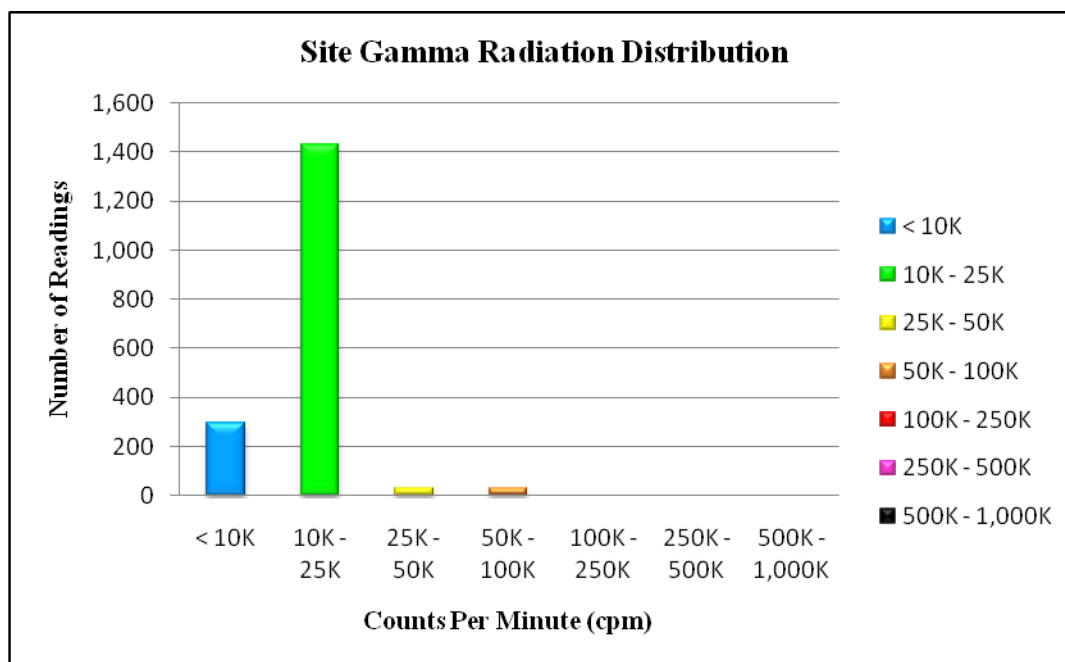
#### Site Gamma Radiation Statistics

Number of Readings	1,789
Minimum (cpm)	6,307
Maximum (cpm)	83,021
Mean (cpm)	14,657
Median (cpm)	13,552
Standard Deviation	7,924

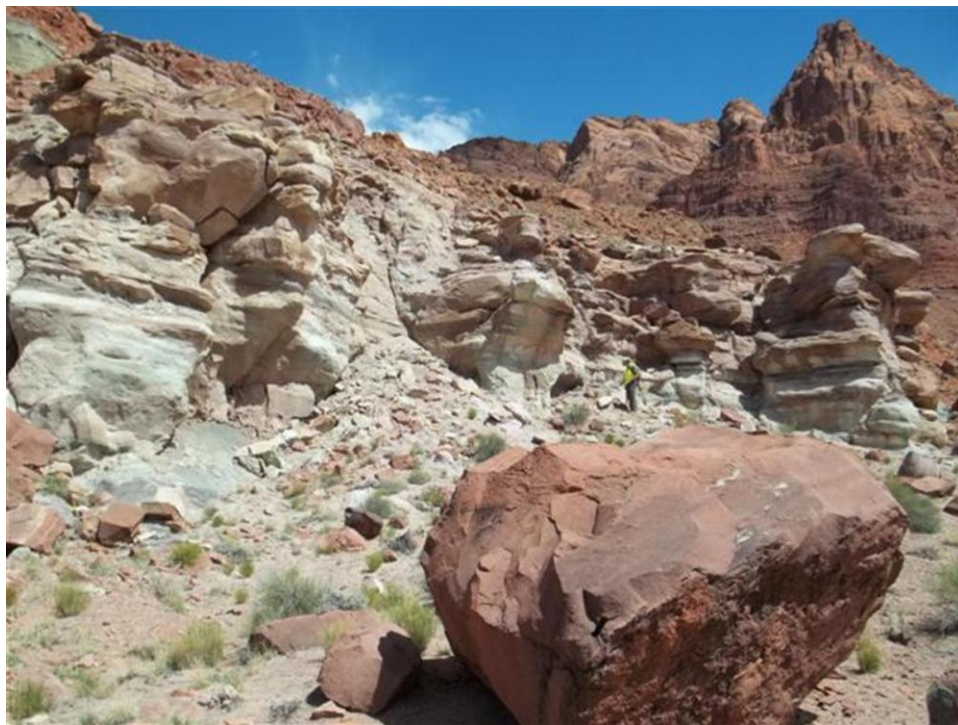
**Photo 1:** Mine Site #533

Possible bench area

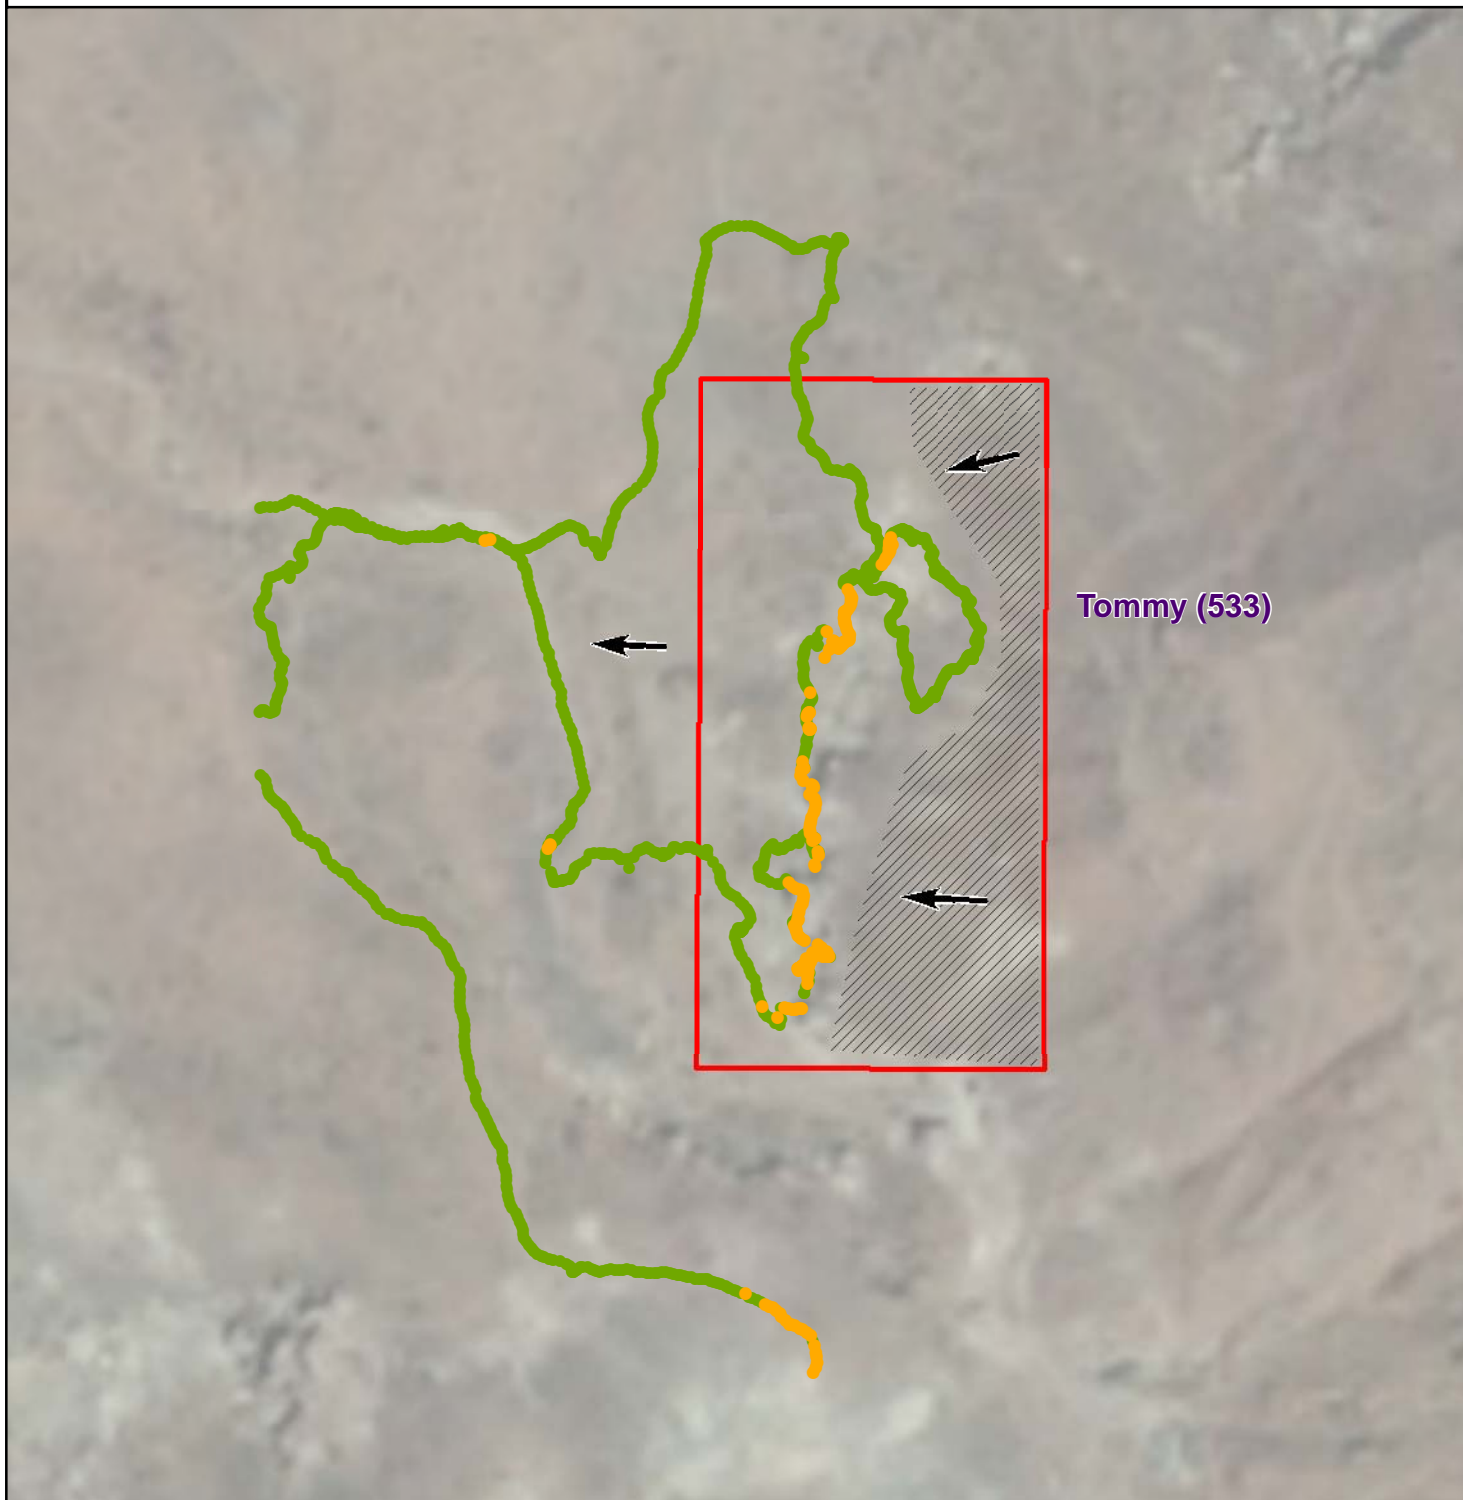
**Figure 1 - Gamma Radiation Measurements, Above Two Times Background  
Tommy (533)  
Bodaway / Gap Chapter, Navajo Nation**

A total of 1,789 gamma radiation measurements were collected from the mine site, ranging from 6,307 cpm to 83,021 cpm. Measurements collected in the vicinity of the bench area were found at a maximum level of approximately 80,000 cpm. The measurements are represented in Figures 1 and 2.
